**Flood Control Project Maintenance  
Levee Inspections**

## Maintenance Issue Types Only, Levee Inspection Report By Mile - Spring 2019

### American River Flood Control District

Waterway	Bank	Unit Miles	Inspection Start/End	Inspector
Unit No. 01 Arcade Creek	Left	2.08	05/14/2019 05/14/2019	Luz Dial

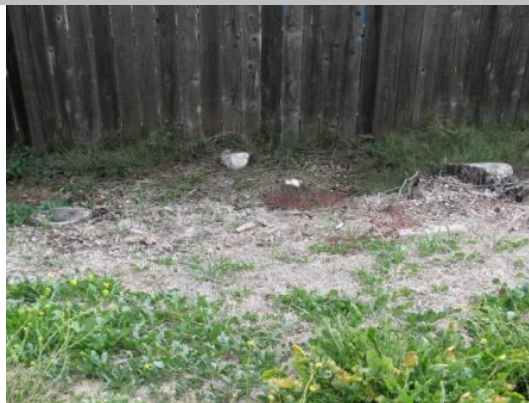
Photo 1 of 1 : SP\_2019\_NA0001\_51\_178\_20190307\_00058.jpg

LM Start	1.36	Rating **	N	Issue No.	178
LM End	1.36	Issue Type +	Ma	Location *	LS
Category	Earthen Levee			GPS Latitude/Longitude	
				Start	End
Item	Trim / Thin Trees			38.626063 °	38.626063 °
				-121.444988 °	-121.444988 °
DWR ID	DWR_NA0001_01_s_2012_178				
Comment Code					
T5 : Tree stumps.					
Inspector Comment					
Two stumps at landside toe.

11/17/2011 Two stumps at levee toe.

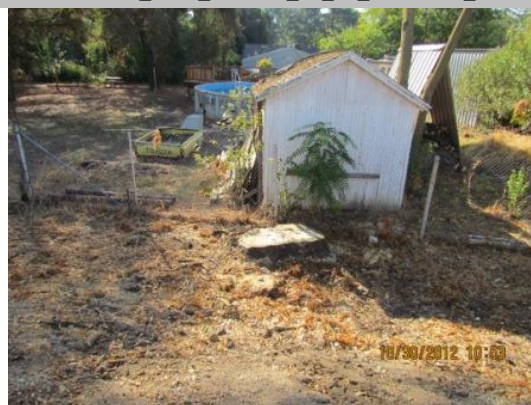
Photo 1 of 1 : SP\_2019\_NA0001\_51\_31\_20190307\_00025.jpg

LM Start	1.61	Rating **	N	Issue No.	31
LM End	1.61	Issue Type +	Ma	Location *	LS
Category	Earthen Levee			GPS Latitude/Longitude	
				Start	End
Item	Trim / Thin Trees			38.627191°	38.627191°
				-121.440861°	-121.440861°
DWR ID	DWR_NA0001_01_f_2012_31				
Comment Code					
T5 : Tree stumps.					
Inspector Comment

View of large tree stump at levee toe.

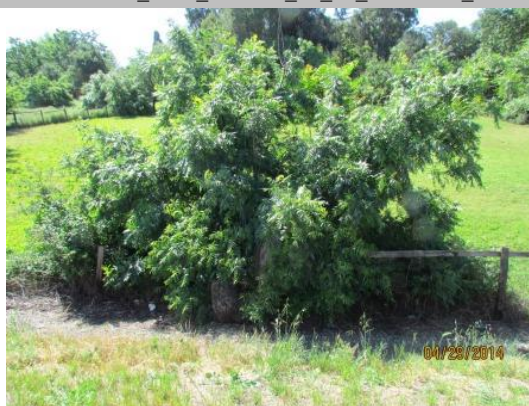
Photo 1 of 1 : SP\_2019\_NA0001\_51\_48\_20190307\_00031.jpg

LM Start	1.69	Rating **	M	Issue No.	48
LM End	1.69	Issue Type +	Ma	Location *	LS
Category	Earthen Levee			GPS Latitude/Longitude	
				Start	End
Item	Vegetation			38.627594 °	38.627594 °
				-121.439540 °	-121.439540 °
DWR ID	DWR_NA0001_01_s_2014_48				
Comment Code					
V2 : Remove the wild growth other than native grasses from the levee slopes.					
Inspector Comment					
Tree obstructing visibility and access.

View of the overgrown tree at the landside levee toe. Spring 2014

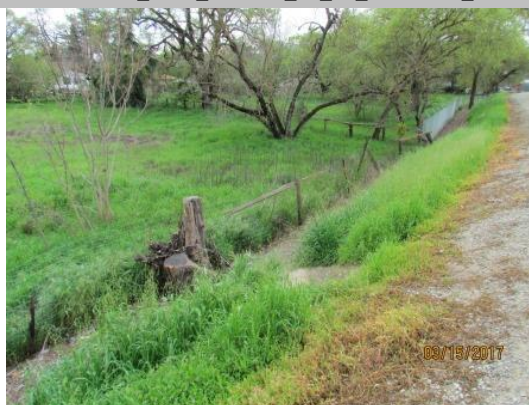
Photo 1 of 1 : SP\_2019\_NA0001\_51\_74\_20190307\_00048.jpg

LM Start	1.69	Rating **	N	Issue No.	74
LM End	1.69	Issue Type +	Ma	Location *	LS
Category	Earthen Levee			GPS Latitude/Longitude	
				Start	End
Item	Trim / Thin Trees			38.627607 °	38.627607 °
				-121.439545 °	-121.439545 °
DWR ID	DWR_NA0001_01_s_2017_74				
Comment Code					
T5 : Tree stumps.					
Inspector Comment					
24 inch large tree stump at levee toe.

View of the tree stump at the levee toe.

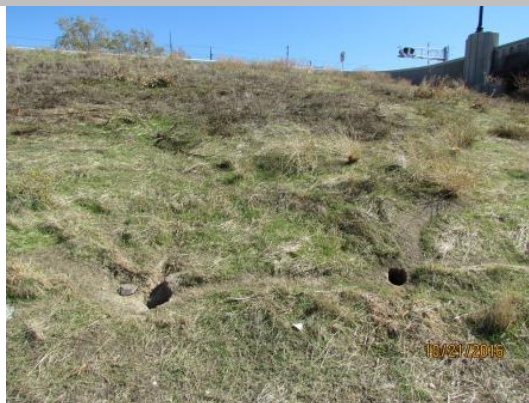
Photo 1 of 1 : SP\_2019\_NA0001\_52\_24\_20190307\_00011.jpg

LM Start	0.73	Rating **	M	Issue No.	24
LM End	0.73	Issue Type +	Ma	Location *	WS
Category	Earthen Levee			GPS Latitude/Longitude	
				Start	End
Item	Animal Control			38.611529 °	38.611529 °
				-121.466801 °	-121.466801 °
DWR ID	DWR_NA0001_02_s_2016_24				
Comment Code					
A3 : No rodents visible, but rodent burrows visible; need to backfill and compact or grout burrows.					
Inspector Comment

View of the rodent holes in the waterside levee slope. Fall 2016

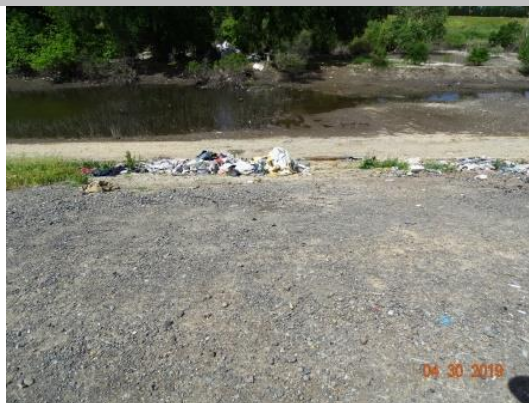
Photo 1 of 1 : SP\_2019\_NA0001\_52\_13\_20190501\_00055.jpg

LM Start	0.93	Rating **	M	Issue No.	13
LM End	0.93	Issue Type +	Ma	Location *	WS
Category	Earthen Levee			GPS Latitude/Longitude	
				Start	End
Item	Encroachments			38.614380 °	38.614380 °
				-121.466684 °	-121.466684 °
DWR ID	DWR_NA0001_02_s_2019_13				
Comment Code					
DE : Debris					
Inspector Comment					
Remove homeless debris from crown and slope.

View of homeless debris on waterside slope. Spring 2019

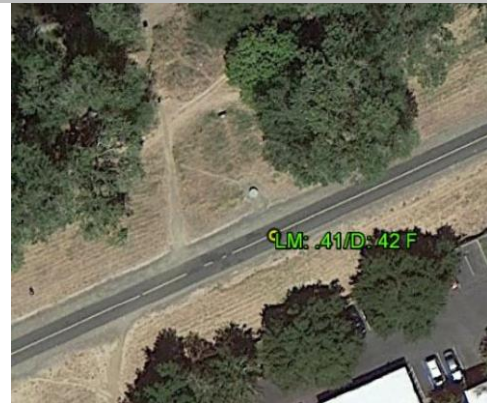
Photo 1 of 3 : UCIP\_SP\_2019\_31249\_57212.jpg

Comment Code						
Inspector Comment						
FS_ID:31249 DS_ID:24303 EP_NO: N/A Repair Type: Non-Urgent Crossing Status: Found UCIP Comments: 08/16/2017 DWR Deferred Maintenance Project (DMP), Vince Rodriguez, forwarded email received from Tim Kerr, General Manager of American River Flood Control District (ARFCD) with file "DWR Eligible Pipes Found in ARFCD" from ARFCD that shows the ownership and location of the pipes Tim Kerr investigated. No owner was identified, ARFCD Staff Notes indicate Abandoned (ARFCD/Bill) - No As-builts. (DWR UCIP - O. Magana) 12/19/2013 Non-functional crossing--need additional information about how crossing was abandoned. (DWR UCIP - O. Magana) FIELD_STRUCT_DESC: *ABANDONED* 42-inch corrugated metal drainage pipe through the levee, 16.5 feet below the crown. Gravel filled with both ends welded shut. Flap gate on the waterside (WS) end. Slide gate in corrugated metal riser and splash board drain structure on the landside (LS). (no permit has been identified authorizing this structure, no owner has been identified) [Additional Reference(s): DWR Levee Log, 2002. USACE Sacramento O&M Manual Unit 118 Part 1, August 1955, (Station 10+00)]. FS Date: 12/19/2013

Overview of crossing location.

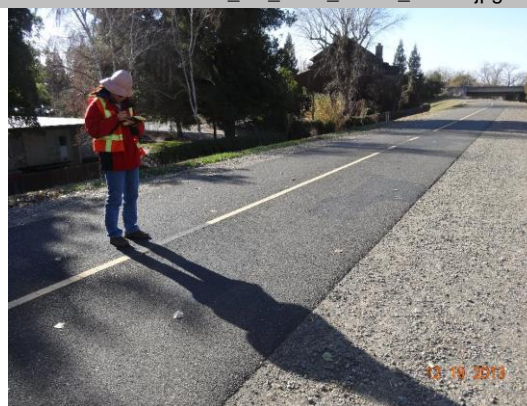
Photo 2 of 3 : UCIP\_SP\_2019\_31249\_57209.jpg

View of levee crown at this location.

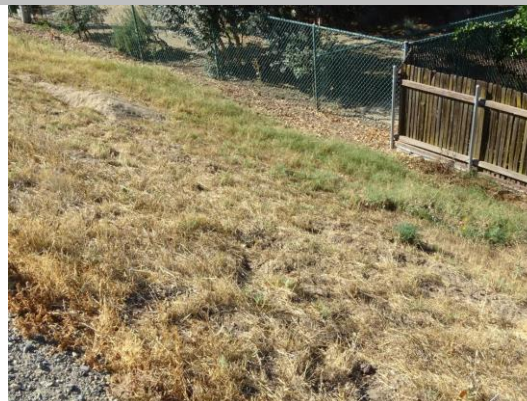
Photo 1 of 1 : SP\_2019\_NA0001\_55\_273\_20190307\_00209.jpg

LM Start	5.92	Rating **	M	Issue No.	273
LM End	5.94	Issue Type +	Ma	Location *	LS
Category	Earthen Levee			GPS Latitude/Longitude	
				Start	End
Item	Animal Control			38.570755 °	38.570395 °
				-121.424206 °	-121.424237 °
DWR ID	DWR_NA0001_04_f_2018_273				
Comment Code					
A3 : No rodents visible, but rodent burrows visible; need to backfill and compact or grout burrows.					
Inspector Comment					
Backfill animal holes.

View of animal burrows. Fall 2018

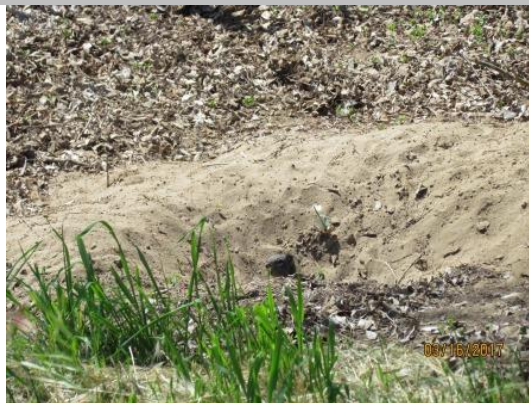
Photo 2 of 2 : SP\_2019\_NA0001\_55\_240\_20190307\_00193.jpg

LM Start	6.62	Rating **	M	Issue No.	240 (cont)	
LM End	6.65	Issue Type +	Ma	Location *	LS	
Category	Earthen Levee			GPS Latitude/Longitude		
				Start		End
Item	Animal Control			38.561121 °		38.560883 °
				-121.420766 °		-121.420514 °
DWR ID	DWR_NA0001_04_s_2017_240					
Comment Code						
A3 : No rodents visible, but rodent burrows visible; need to backfill and compact or grout burrows.						
Inspector Comment						
Only two rodent burrows were visible due to vegetation.

Another view of the rodent burrow at the levee toe.

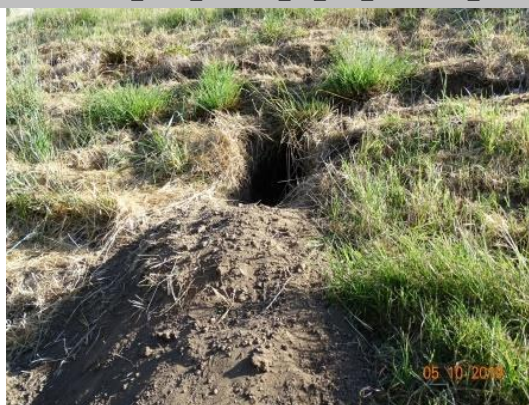
Photo 1 of 1 : SP\_2019\_NA0001\_55\_285\_20190515\_00271.jpg

LM Start	6.87	Rating **	U	Issue No.	285
LM End	6.87	Issue Type +	Ma	Location *	LS
Category	Earthen Levee			GPS Latitude/Longitude	
				Start	End
Item	Animal Control			38.558618 °	38.558618 °
				-121.417515 °	-121.417515 °
DWR ID	DWR_NA0001_04_s_2019_285				
Comment Code					
A3 : No rodents visible, but rodent burrows visible; need to backfill and compact or grout burrows.					
Inspector Comment					
There is a large animal burrow into the levee slope.

View looking north at large animal hole on the levee slope within the City facility. Spring 2019

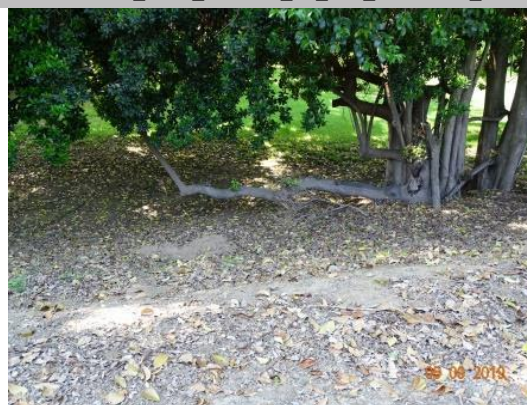
Photo 1 of 1 : SP\_2019\_NA0001\_55\_255\_20190515\_00268.jpg

LM Start	8.71	Rating **	M	Issue No.	255	
LM End	8.73	Issue Type +	Ma	Location *	LS	
Category	Earthen Levee			GPS Latitude/Longitude		
				Start		End
Item	Animal Control			38.564483 °		38.564530 °
				-121.385365 °		-121.385015 °
DWR ID	DWR_NA0001_04_s _ 2019_255					
Comment Code						
A1 : Exterminate rodents and backfill and compact or grout burrows.						
Inspector Comment						
Backfill animal holes on levee slope.

View looking south at animal holes on the levee slope. Spring 2019

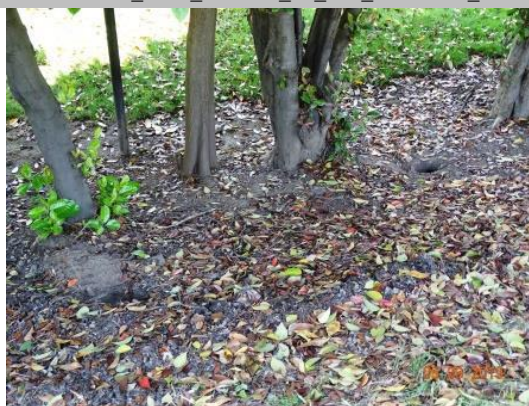
Photo 1 of 1 : SP\_2019\_NA0001\_55\_249\_20190515\_00267.jpg

LM Start	8.77	Rating **	M	Issue No.	249
LM End	8.77	Issue Type +	Ma	Location *	LS
Category	Earthen Levee			GPS Latitude/Longitude	
				Start	End
Item	Animal Control			38.564700 °	38.564700 °
				-121.384197 °	-121.384197 °
DWR ID	DWR_NA0001_04_s_2019_249				
Comment Code					
A3 : No rodents visible, but rodent burrows visible; need to backfill and compact or grout burrows.					
Inspector Comment					
Backfill two large animal holes at levee toe and one small hole at the shoulder.

View looking south at large animal holes on the levee slope. Spring 2019

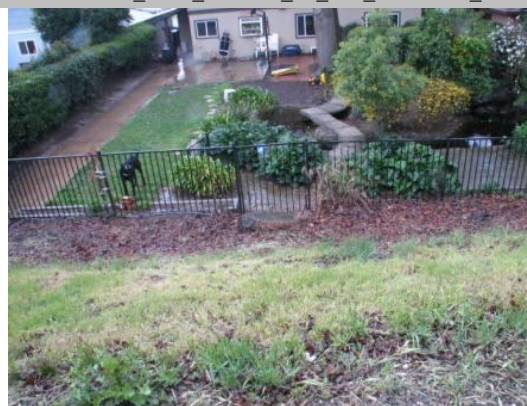
Photo 1 of 1 : SP\_2019\_NA0001\_55\_123\_20190307\_00110.jpg

LM Start	9.56	Rating **	N	Issue No.	123
LM End	9.56	Issue Type +	Ma	Location *	LS
Category	Earthen Levee			GPS Latitude/Longitude	
				Start	End
Item	Trim / Thin Trees			38.567246 °	38.567246 °
				-121.370146 °	-121.370146 °
DWR ID	DWR_NA0001_04_s_2012_123				
Comment Code					
T5 : Tree stumps.					
Inspector Comment					
Trees, tree stump, bushes, and ground cover are within 10-ft of levee toe.

03/16/2012 Large tree stump at levee toe.

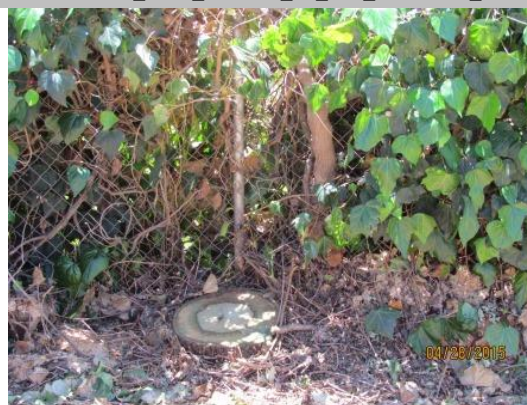
Photo 1 of 1 : SP\_2019\_NA0001\_55\_234\_20190307\_00189.jpg

LM Start	9.72	Rating **	N	Issue No.	234
LM End	9.72	Issue Type +	Ma	Location *	LS
Category	Earthen Levee			GPS Latitude/Longitude	
				Start	End
Item	Trim / Thin Trees			38.567761 °	38.567761 °
				-121.367363 °	-121.367363 °
DWR ID	DWR_NA0001_04_s_2015_234				
Comment Code					
T5 : Tree stumps.					
Inspector Comment

View of the tree stump at the landside levee toe.

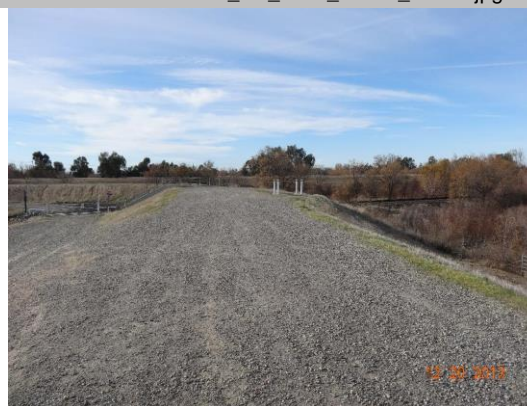
Photo 1 of 3 : UCIP\_SP\_2019\_26884\_49630.jpg

LM Start	0.02	Rating **	A/W	Issue No.	8
LM End	0.02	Issue Type +	Ma	Location *	
Category	Supplemental			GPS Latitude/Longitude	
				Start	End
Item	DWR UCIP LMA Responsibility		38.657400 °	38.657400 °	
			-121.474455 °	-121.474455 °	
DWR ID	24092				
Comment Code					
Inspector Comment					
FS_ID:26884 DS_ID:24092 EP_NO: N/A Repair Type: No Action Needed Crossing Status: Found UCIP Comments: FIELD_STRUCT_DESC: 24-inch corrugated metal (CM) drainage pipe through the levee, 22.7 feet below the crown. Two CM cutoff walls around pipe. Slide gate in 30-inch CM riser and flap gate at located on the waterside (WS) end. Concrete headwalls on both ends, WS and landside (LS). [Additional Reference(s): DWR Levee Log, 2002. USACE Sacramento O&M Manual Unit 118 Part 2, August 1959, Drawing No. 1-4-392 of Exhibit B, (Station 396+65)]. FS Date: 12/20/2013

View of levee crown at crossing.

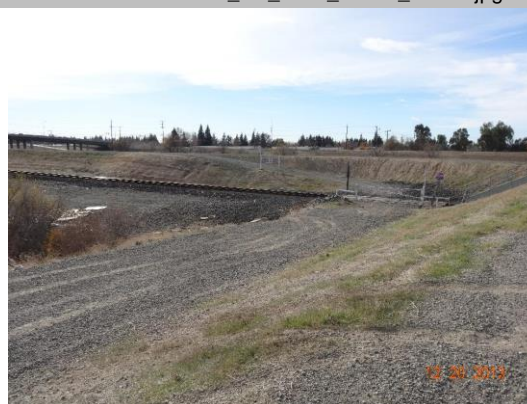
Photo 2 of 3 : UCIP\_SP\_2019\_26884\_49629.jpg

View of landward side.

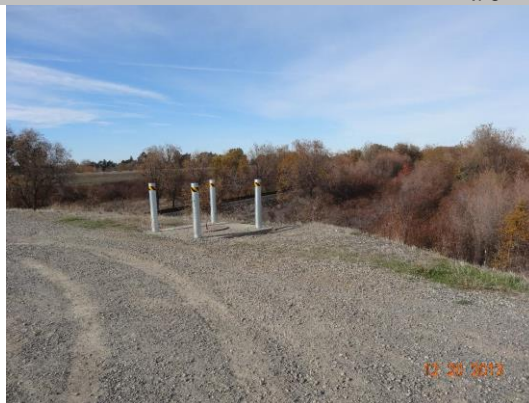
Photo 3 of 3 : UCIP\_SP\_2019\_26884\_49628.jpg

LM Start	0.02	Rating **	A/W	Issue No.	8 (cont)	
LM End	0.02	Issue Type +	Ma	Location *		
Category	Supplemental			GPS Latitude/Longitude		
				Start		End
Item	DWR UCIP LMA Responsibility			38.657400 °		38.657400 °
				-121.474455 °		-121.474455 °
DWR ID	24092					
Comment Code						
Inspector Comment						
FS_ID:26884 DS_ID:24092 EP_NO: N/A Repair Type: No Action Needed Crossing Status: Found UCIP Comments: FIELD_STRUCT_DESC: 24-inch corrugated metal (CM) drainage pipe through the levee, 22.7 feet below the crown. Two CM cutoff walls around pipe. Slide gate in 30-inch CM riser and flap gate at located on the waterside (WS) end. Concrete headwalls on both ends, WS and landside (LS). [Additional Reference(s): DWR Levee Log, 2002. USACE Sacramento O&M Manual Unit 118 Part 2, August 1959, Drawing No. 1-4-392 of Exhibit B, (Station 396+65)]. FS Date: 12/20/2013

Concrete vault protected by posts located on waterward shoulder.

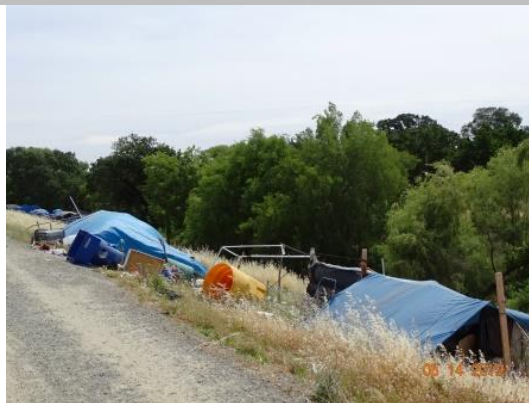
Photo 1 of 1 : SP\_2019\_NA0001\_58\_36\_20190516\_00050.jpg

LM Start	0.42	Rating **	M	Issue No.	36
LM End	0.44	Issue Type +	Ma	Location *	WS
Category	Earthen Levee			GPS Latitude/Longitude	
				Start	End
Item	Encroachments			38.623653 °	38.623803 °
				-121.461383 °	-121.461138 °
DWR ID	DWR_NA0001_07_s_2019_36				
Comment Code					
DE : Debris					
Inspector Comment					
Remove homeless debris from levee shoulder.

View looking upstream at homeless debris on levee shoulder. Spring 2019

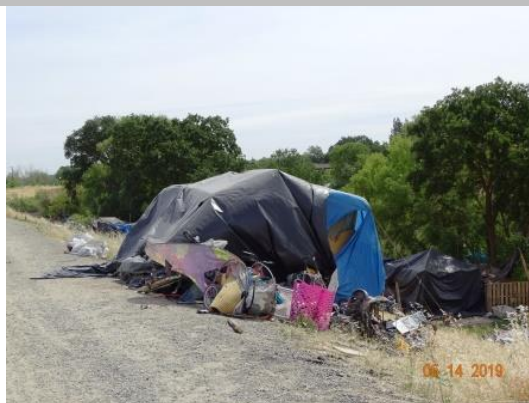
Photo 1 of 1 : SP\_2019\_NA0001\_58\_42\_20190516\_00051.jpg

LM Start	0.46	Rating **	M	Issue No.	42
LM End	0.46	Issue Type +	Ma	Location *	WS
Category	Earthen Levee			GPS Latitude/Longitude	
				Start	End
Item	Encroachments			38.623950 °	38.623950 °
				-121.460677 °	-121.460677 °
DWR ID	DWR_NA0001_07_s_2019_42				
Comment Code					
DE : Debris					
Inspector Comment					
Remove homeless debris on shoulder.

View looking upstream at homeless debris on levee shoulder. Spring 2019

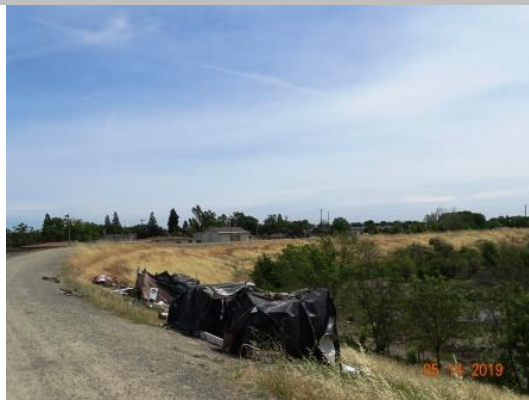
Photo 1 of 1 : SP\_2019\_NA0001\_58\_45\_20190516\_00052.jpg

LM Start	0.56	Rating **	M	Issue No.	45
LM End	0.57	Issue Type +	Ma	Location *	WS
Category	Earthen Levee			GPS Latitude/Longitude	
				Start	End
Item	Encroachments			38.624833 °	38.624988 °
				-121.459402 °	-121.459302 °
DWR ID	DWR_NA0001_07_s_2019_45				
Comment Code					
DE : Debris					
Inspector Comment					
Remove homeless debris on shoulder and slope.

View looking upstream at homeless debris on levee shoulder and slope.  
Spring 2019

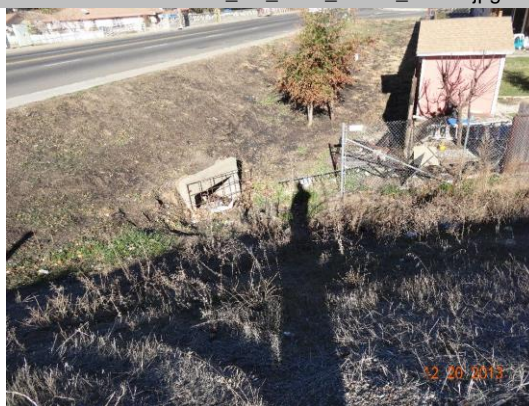
Photo 2 of 3 : UCIP\_SP\_2019\_29301\_54277.jpg

View of landward side.

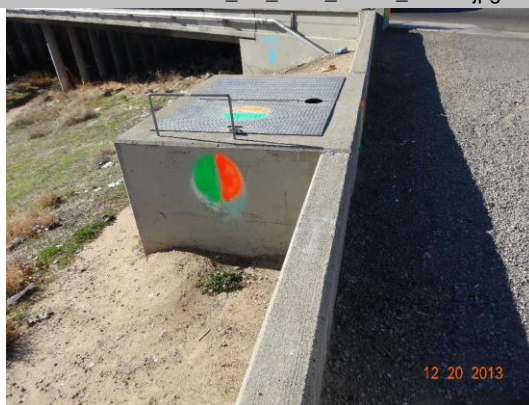
Photo 3 of 3 : UCIP\_SP\_2019\_29301\_54276.jpg

Concrete vault located on waterward shoulder.

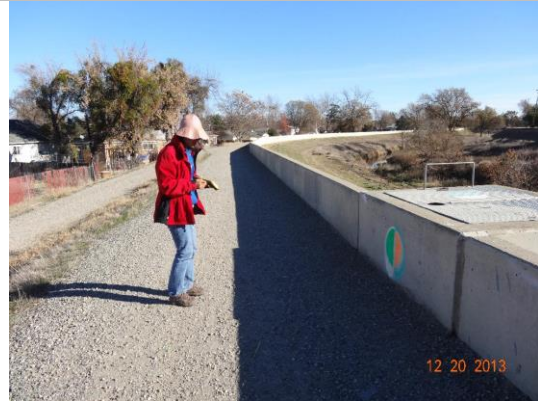
Photo 1 of 3 : UCIP\_SP\_2019\_29302\_54282.jpg

View of levee crown--flood wall located along waterward shoulder.

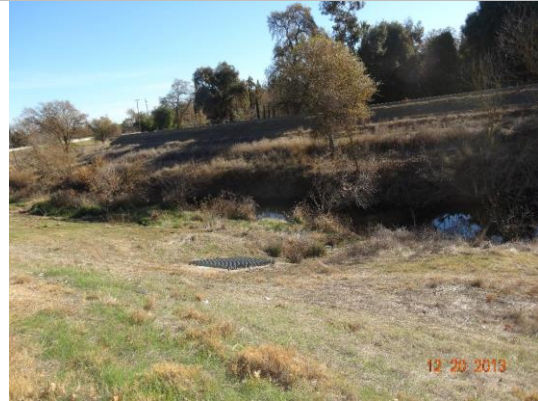
Photo 2 of 3 : UCIP\_SP\_2019\_29302\_54283.jpg

Headwall with debris screen located at waterward toe.

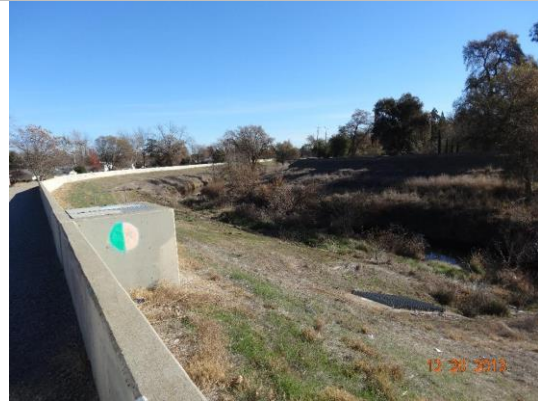
Photo 3 of 3 : UCIP\_SP\_2019\_29302\_54284.jpg

View of waterward side--concrete vault and headwall.

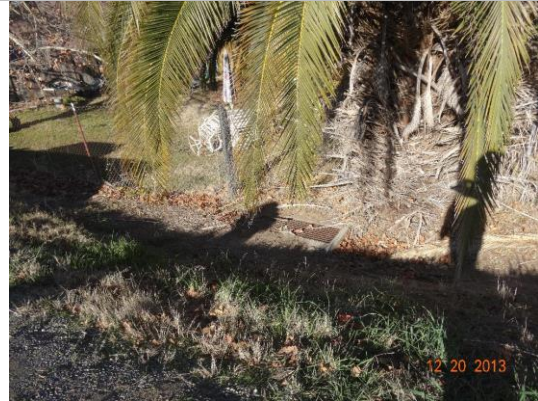
Photo 1 of 3 : UCIP\_SP\_2019\_29324\_54305.jpg

View of landward side.

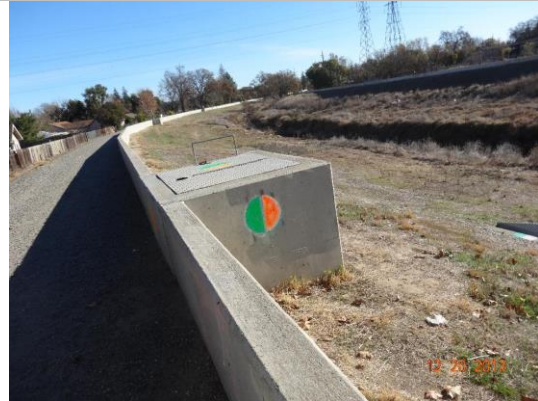
Photo 2 of 3 : UCIP\_SP\_2019\_29324\_54307.jpg

Floodwall along waterward shoulder.

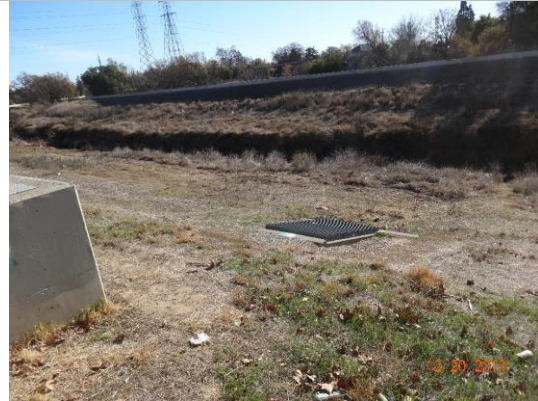
Photo 3 of 3 : UCIP\_SP\_2019\_29324\_54306.jpg

Concrete headwall with debris screen located on waterward toe.

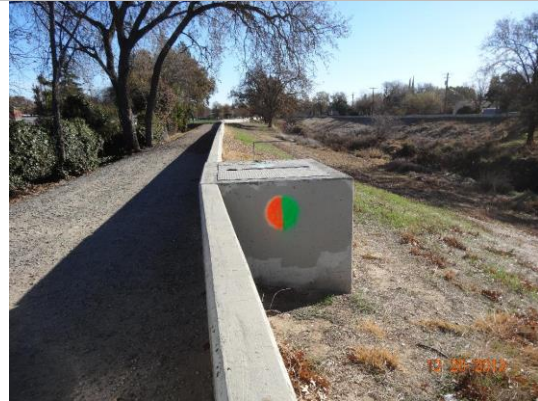
Photo 1 of 3 : UCIP\_SP\_2019\_29326\_54319.jpg

Floodwall along waterward shoulder for almost entire Unit.

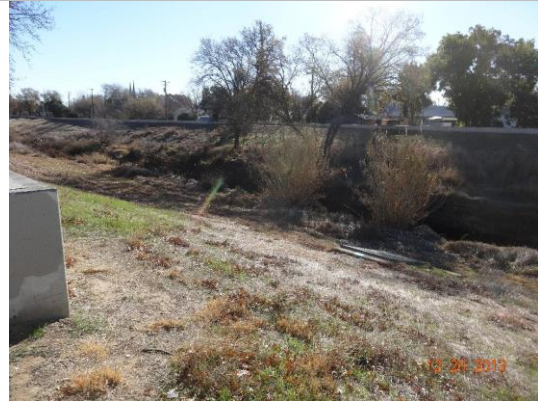
Photo 2 of 3 : UCIP\_SP\_2019\_29326\_54318.jpg

View of waterward slope.

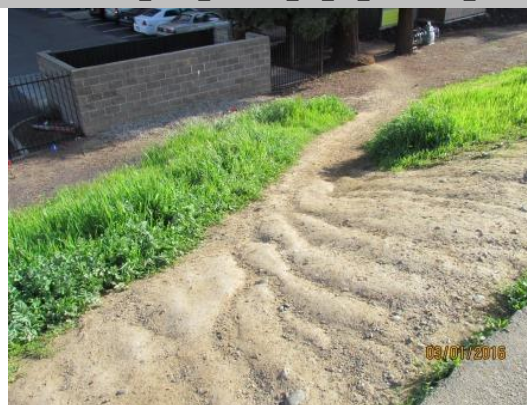
Photo 1 of 1 : SP\_2019\_NA0001\_60\_28\_20190307\_00010.jpg

LM Start	1.88	Rating **	M	Issue No.	28
LM End	1.88	Issue Type +	Ma	Location *	LS
Category	Earthen Levee			GPS Latitude/Longitude	
				Start	End
Item	Slope Stability			38.561171 °	38.561171 °
				-121.415808 °	-121.415808 °
DWR ID	DWR_NA0001_09_s_2016_28				
Comment Code					
S2 : Repair the levee slope damaged by foot traffic and prevent access where possible.					
Inspector Comment

View of the landside levee slope.

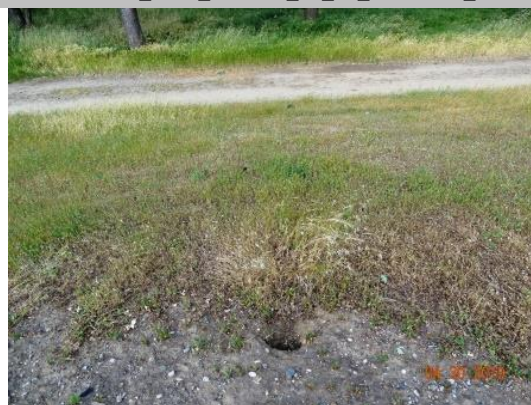
Photo 1 of 1 : SP\_2019\_NA0001\_60\_19\_20190501\_00046.jpg

LM Start	2.17	Rating **	A/W	Issue No.	19
LM End	2.17	Issue Type +	Ma	Location *	WS
Category	Earthen Levee			GPS Latitude/Longitude	
				Start	End
Item	Animal Control			38.563904 °	38.563904 °
				-121.419690 °	-121.419690 °
DWR ID	DWR_NA0001_09_f_2018_19				
Comment Code					
A3 : No rodents visible, but rodent burrows visible; need to backfill and compact or grout burrows.					
Inspector Comment					
Monitor rodent activity and backfill hole.

View of rodent hole on levee slope. Spring 2019

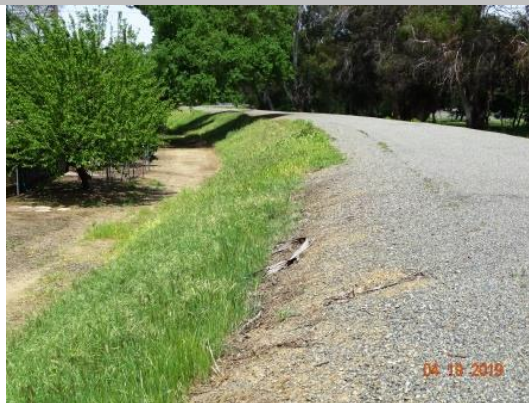
Photo 1 of 1 : SP\_2019\_NA0001\_61\_20\_20190422\_00047.jpg

LM Start	0.63	Rating **	A	Issue No.	20
LM End	0.63	Issue Type +	Ma	Location *	LS
Category	Earthen Levee			GPS Latitude/Longitude	
				Start	End
Item	Vegetation			38.592035 °	38.592035 °
				-121.334450 °	-121.334450 °
DWR ID	DWR_NA0001_10_s_2019_20				
Comment Code					
V1 : Control annual grass and weeds on the levee slopes and easements.					
Inspector Comment					
Annual vegetation is well-maintained.

View looking upstream at well-maintained landside vegetation. Spring 2019

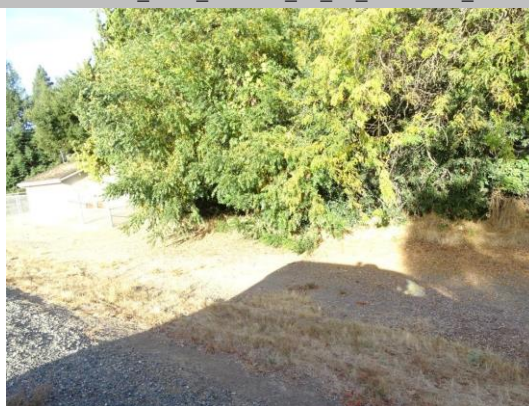
Photo 1 of 1 : SP\_2019\_NA0001\_61\_25\_20190307\_00005.jpg

LM Start	1.51	Rating **	M	Issue No.	25
LM End	1.51	Issue Type +	Ma	Location *	LS
Category	Earthen Levee			GPS Latitude/Longitude	
				Start	End
Item	Encroachments			38.581745 °	38.581745 °
				-121.343357 °	-121.343357 °
DWR ID	DWR_NA0001_10_f_2018_25				
Comment Code					
TR : Tree or limb					
Inspector Comment					
Vegetation partially obstructs access.

View of vegetation at landside toe. Fall 2018

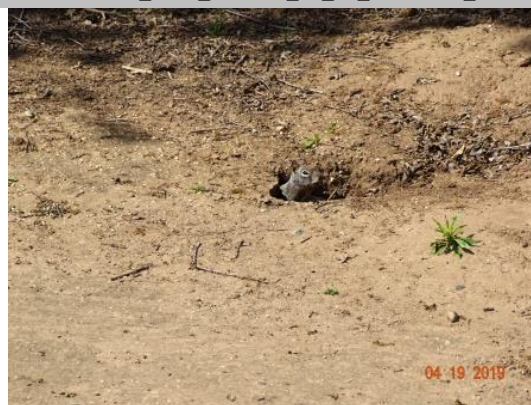
Photo 1 of 2 : SP\_2019\_NA0001\_61\_36\_20190422\_00048.jpg

LM Start	2.07	Rating **	M	Issue No.	36
LM End	2.07	Issue Type +	Ma	Location *	LS
Category	Earthen Levee			GPS Latitude/Longitude	
				Start	End
Item	Animal Control			38.577573 °	38.577573 °
				-121.352332 °	-121.352332 °
DWR ID	DWR_NA0001_10_s_2019_36				
Comment Code					
A1 : Exterminate rodents and backfill and compact or grout burrows.					
Inspector Comment

View of squirrel hole with activity along toe road. Spring 2019

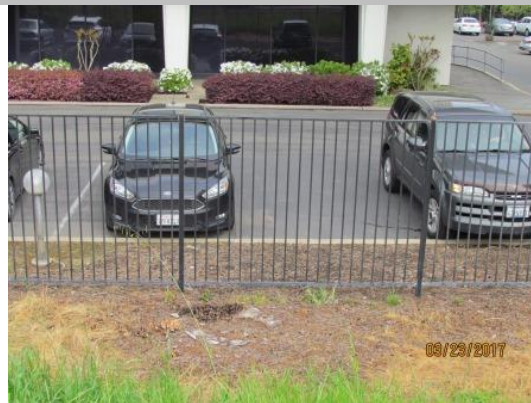
Photo 1 of 1 : SP\_2019\_NA0001\_61\_28\_20190307\_00008.jpg

LM Start	3.77	Rating **	N	Issue No.	28	
LM End	3.77	Issue Type +	Ma	Location *	LS	
Category	Earthen Levee			GPS Latitude/Longitude		
				Start		End
Item	Trim / Thin Trees			38.568375 °		38.568375 °
				-121.380889 °		-121.380889 °
DWR ID	DWR_NA0001_10_s_2017_28					
Comment Code						
T5 : Tree stumps.						
Inspector Comment

View of the tree stump at the levee toe. Spring 2017
